## Experimental evaluation of damage state and failure propagation of infilled frames under the opening effect

**Abstract:** In this study, four frame specimens were tested: two with concentric window and door openings in the infills, and two with eccentric window and door openings. The serviceability limit of the infilled state was determined by evaluating the structural behaviour of infilled reinforced concrete frames with openings. The results indicate that frames with centrally located openings exhibit a reduction in lateral load capacity. The damage characteristics are influenced more by the location of the opening than by its percentage. When the opening is positioned closer to the edge of the masonry panel, the structural performance improves. Initial cracking occurs at a lateral drift of 0.2%, while crushing of the masonry panel occurs at approximately 2%. In frames with centrally located openings, the segment near the loaded column is more prone to damage, whereas the segment farther from the loaded column shows increased vulnerability.

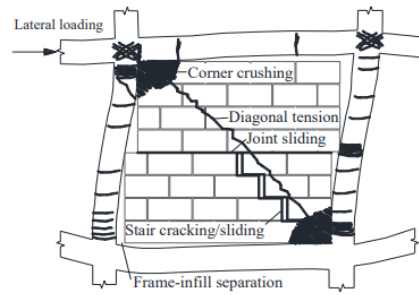
**Figure 1:** Typical masonry infill wall failure modes

During an earthquake, infill masonry walls may be subjected to two types of loading, depending on their orientation relative to the principal direction of seismic excitation: in-plane loads and face loads that can result in out-of-plane collapse [1][2]. Commonly observed in-plane failure modes include sliding along mortar bed joints, diagonal cracking through masonry units, step cracking or sliding along mortar joints, and toe crushing. These typical failure modes are illustrated in Figure 1.

The frequently observed in-plane failure modes encompass sliding along mortar bed joints, diagonal cracking through masonry units, step cracking or sliding along mortar joints, and toe crushing. Commonly recognized failure patterns for masonry infills are depicted in Figure 1 [11]. It can be suggested that damage states in infilled frames can be classified by measuring crack widths, which are then correlated with the proposed IDR threshold values [12]. In Table 1, the damage states of the infilled frame classified by the four researchers and FEMA are described by considering the description of the damage and mechanical properties of infill walls [3], [5], [7], [13], [15] .

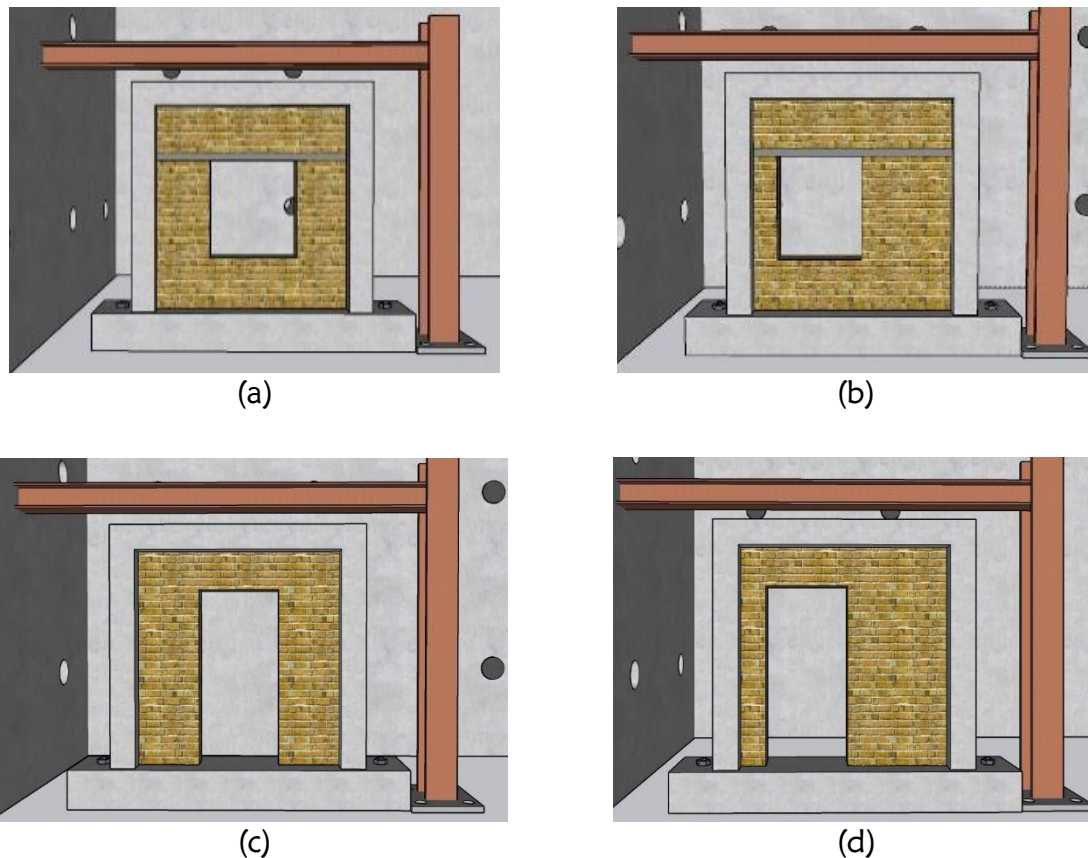
**Figure 2:** Configuration of the infilled frame. (a) Infilled frame with central window (CW), (b) Infilled frame with eccentric window (EW), (c) Infilled frame with central door (CD), and (d) Infilled frame with eccentric door (ED)

In this study, the four tests were conducted to study the lateral response of infilled frame with the different size and location of opening in infilled frame. The window opening of (457 mm x 610 mm) and the door opening of (419 mm x 1067 mm) were located at the center and at the edge as described in Figure 2. The lateral load is applied at the top corner of the column monotonically and the crack propagation of frame was recorded by digital monitoring.

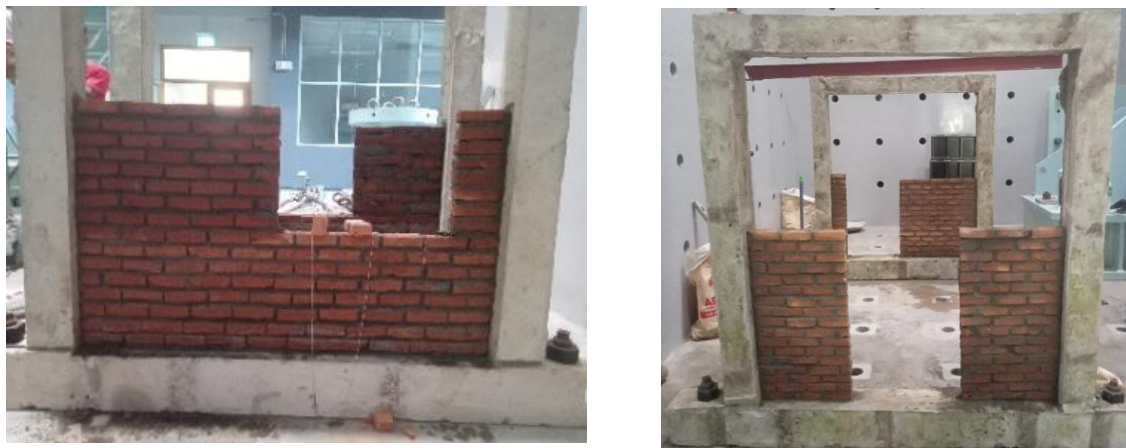
**Figure 4:** Construction sequence of the wall assemblies

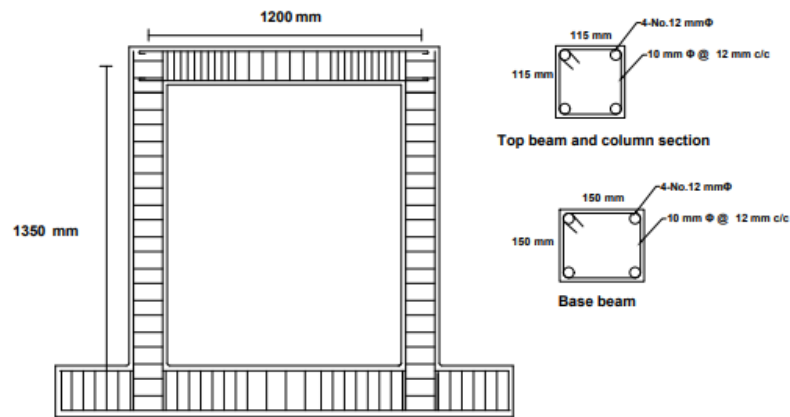
**Figure 5:** Reinforcement detailing of reinforced concrete frame

The four half-scaled frames were tested to measure the lateral response of infilled frame due to the different opening parameter and location as centrally and eccentrically. The dimension of the frame was measured as 1200 mm long between the center of columns and 1350 mm high above the based beam. The reinforced concrete frame was constructed as detailed description shown in Figure 5. The hand-made clay brick was used to construct the masonry wall and the half-scale brick (108.3 mm x 50.8 mm and 31 mm) was obtained from cutting of full-scale brick. The preparation of mortar which is composed of 1 part of cement by 3 parts of sand was controlled and it was observed that the water-cement ratio varied from 0.7 to 0.8 for various mixes to obtain workable mortar. The 32 layers of brick work for masonry wall is built with 7 to 10 mm thickness of mortar layer for longitudinal and transverse joint.

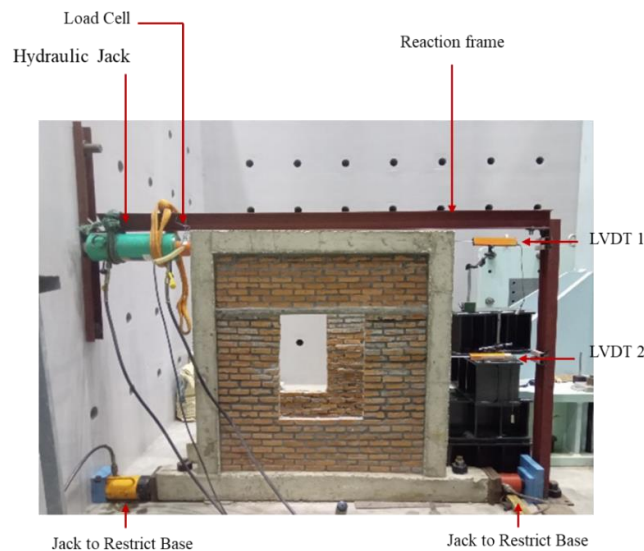
**Figure 6:** Test setup of infilled frame

To determine the performance of masonry infilled wall under lateral load condition, the hydraulic jack was used to apply lateral load at upper left corner of frame as shown in Figure 6. The base member was considered as the foundation of the frame and attached firmly with the base slab of laboratory room by using bolt connection. The two LVDTs were set up top and midpoint of frame to measure the lateral displacement. The load was applied monotonically to reach the crushing failure using a 500kN hydraulic jack. A 12.5 mm steel plate was placed between frame and hydraulic jack to avoid stress concentration.

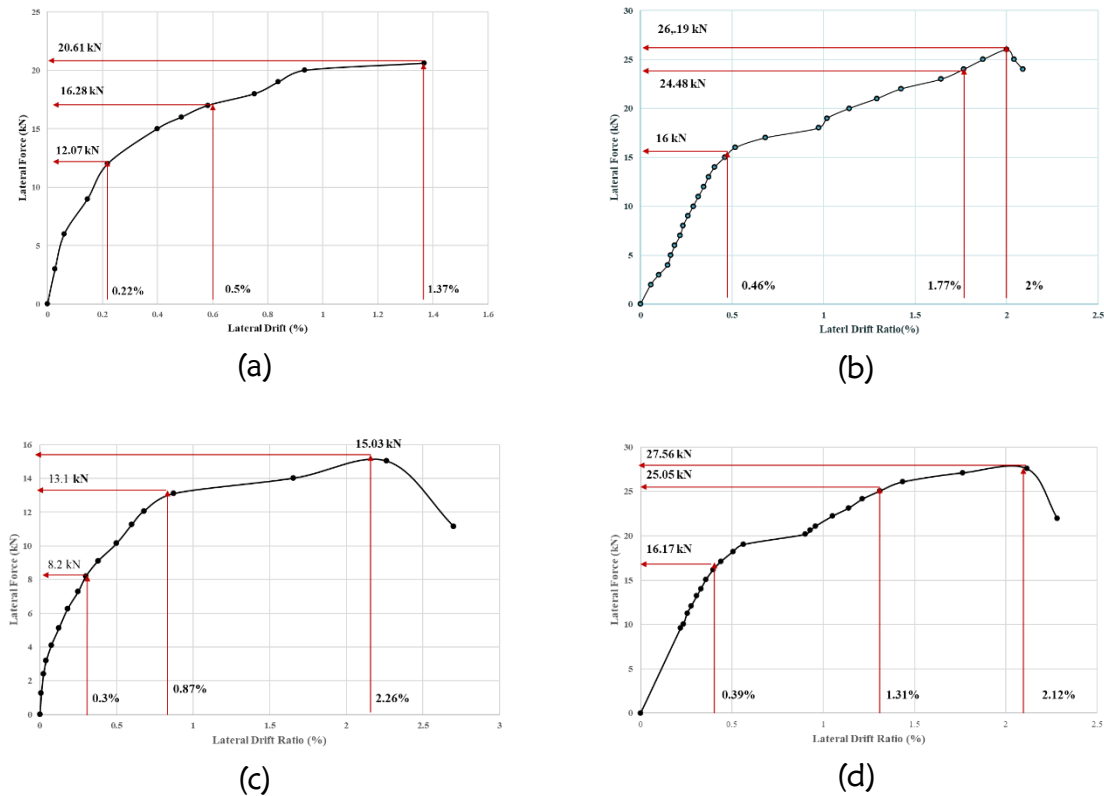
**Figure 7:** Capacity curve with damage state description. (a) CW Frame, (b) EW Frame, (c) CD Frame, and (d) ED Frame

A load-displacement response has been observed as shown in Figure 7. It must be pointed out that the lateral load capacity of infilled frame with eccentric opening is higher than

The four tests were performed to observe the behavior of infilled frame under lateral force. In the first frame including central window opening, the lateral drift ratio at the maximum lateral load of 20.61 kN was 1.37. At the lateral force of 12.07 kN at the drift ratio of 0.2%, the DS1 occurs as the hair line crack on the masonry wall starts from lower corner of opening on the side away from the loading applied face. This is due to the shear failure in the unit/mortar bond area. It is stated as DS2 that the hair line crack extends diagonally on the surface of masonry between the windward column and opening as shown in Figure at 0.5% of drift ratio and 16.28 kN. At the upper left corner of the infill wall near windward column, the diagonal crushing which is crushing and splitting failure in the units (DS3) occurs at 1.37% drift corresponding with 20.61 kN.

The second test on the reinforced concrete frame with an eccentric window opening was conducted in a manner similar to that of the first sample. The opening was positioned near the column, and a monotonically increasing lateral force was applied. When the applied load reached 14 kN, the displacement of the infilled frame measured 5.56 mm, corresponding to a drift ratio of 0.4%. At this load, a diagonal crack initiated from the upper opposite side of the loaded face. Diagonal crushing began at the loaded corner, extending towards the top opposite corner of the window and continuing to the

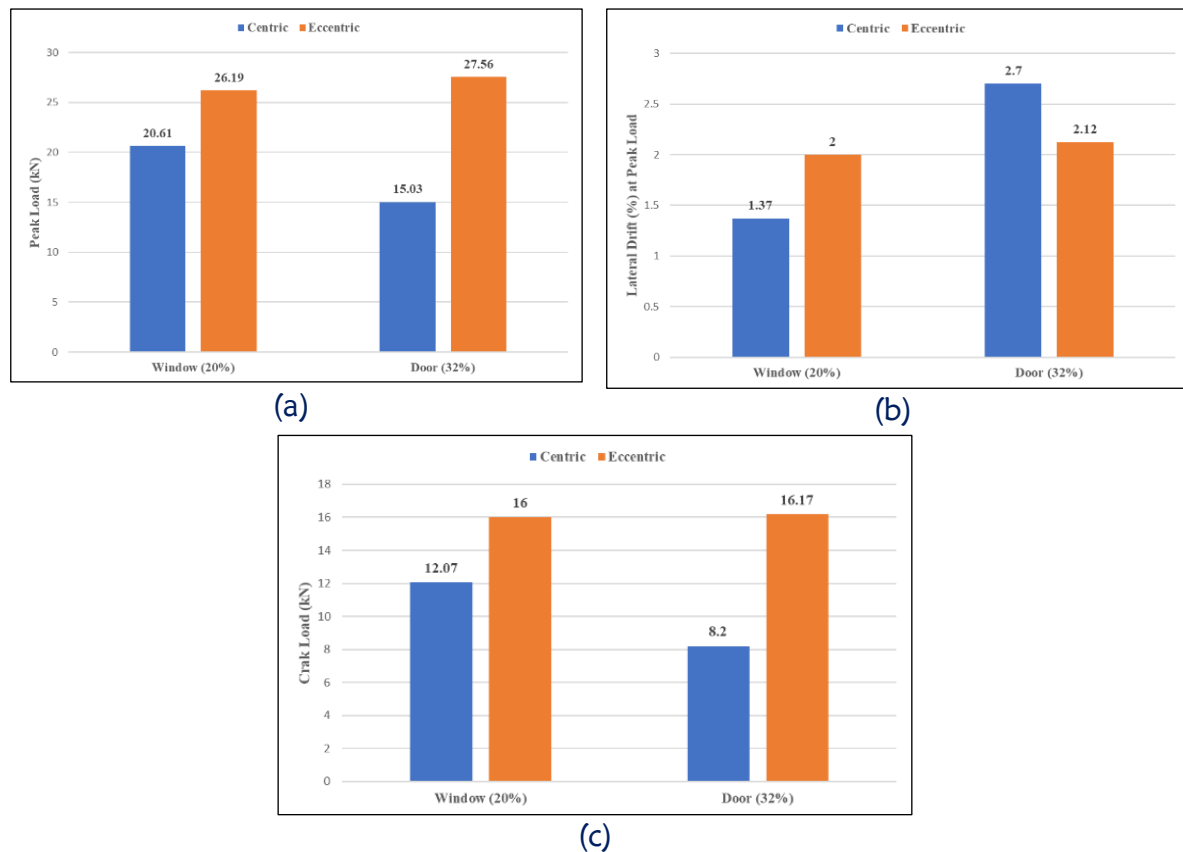
**Figure 8:** Comparison of peak load, lateral drift at peak load and crack load

These results indicate that the lateral capacity of the frame with an eccentric door opening exceeds that of a frame with a central door opening. In comparing the results, the peak load decreases from 20.61 kN to 15.03 kN as the central opening area increases from 20% to 32%. The lateral drift is observed to be 1.37% in the masonry wall with a central window opening and 2.7% with a central door opening. The initial crack appears earlier in the frame with a central door opening, occurring at 8.02 kN, which is approximately 60% of the value for the frame with a central window opening. However, there is no remarkable difference in the three parameters of peak load, lateral drift at peak load, and crack load.
